Central slice of image quality phantom reconstructed with STIR for the Discovery ST scanner geometry showing heavy attenuation in the center of the spheres.

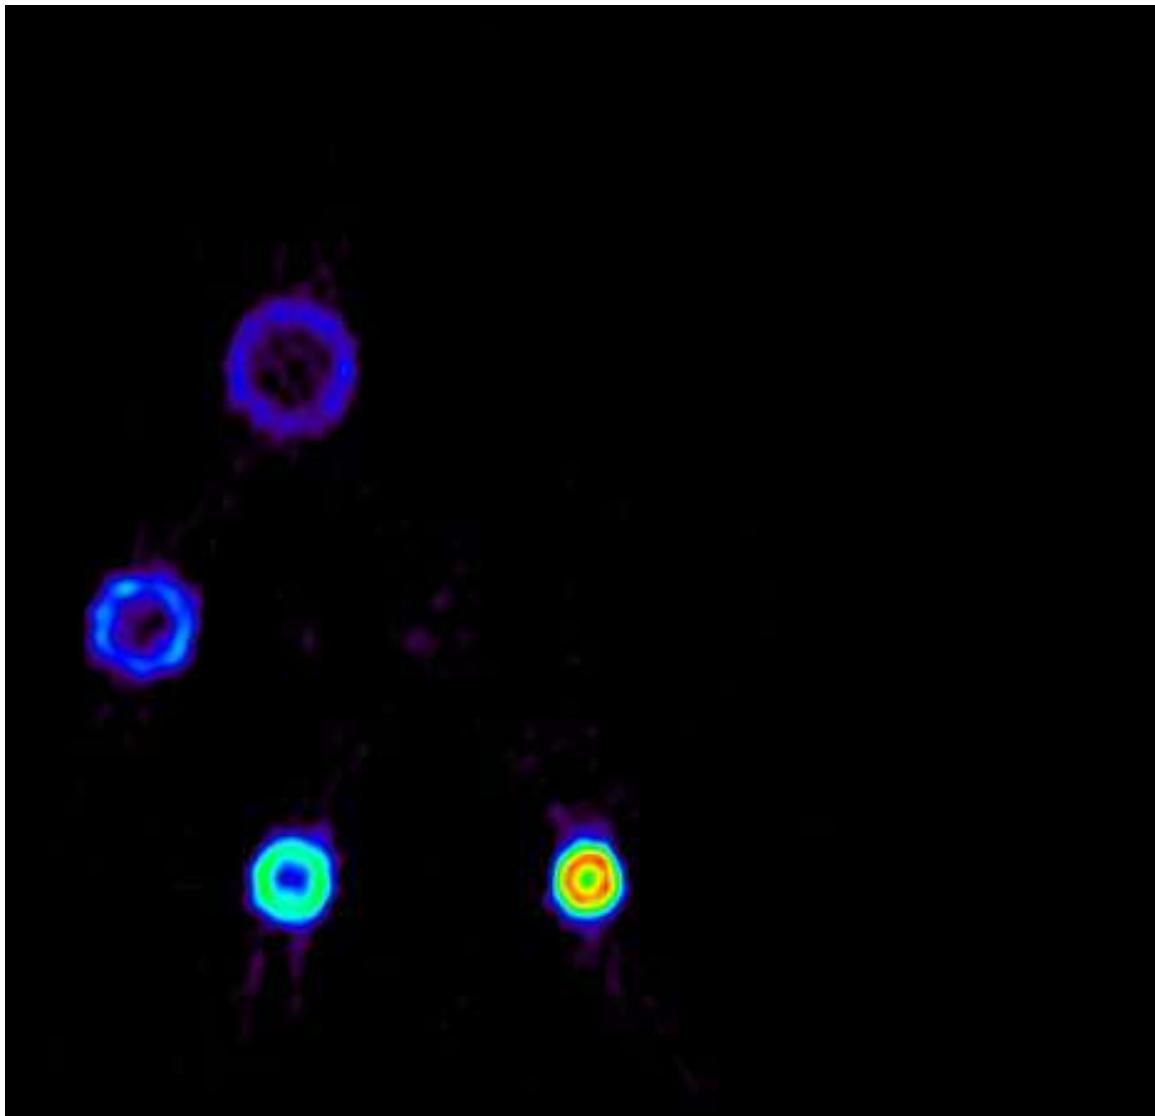
Please comment on this image. I can't recover the exact activities (two spheres are missing in the image, very low activity also the background seems to be COLD but i had made it warm).

It could also be that I used a large zoom in reconstructing the image hence the whole scanner FOV is not covered OR ?
